**Evaluation Sheet For National Register Eligibility  
Potential Historic District Form**

- 1) **Location:** Millville, Baltimore Hundred, Sussex County, Delaware  
Potential: Unknown (outside scope of work) outside of Area of Potential Effect (APE)  
Historic District: No

**Millville District**

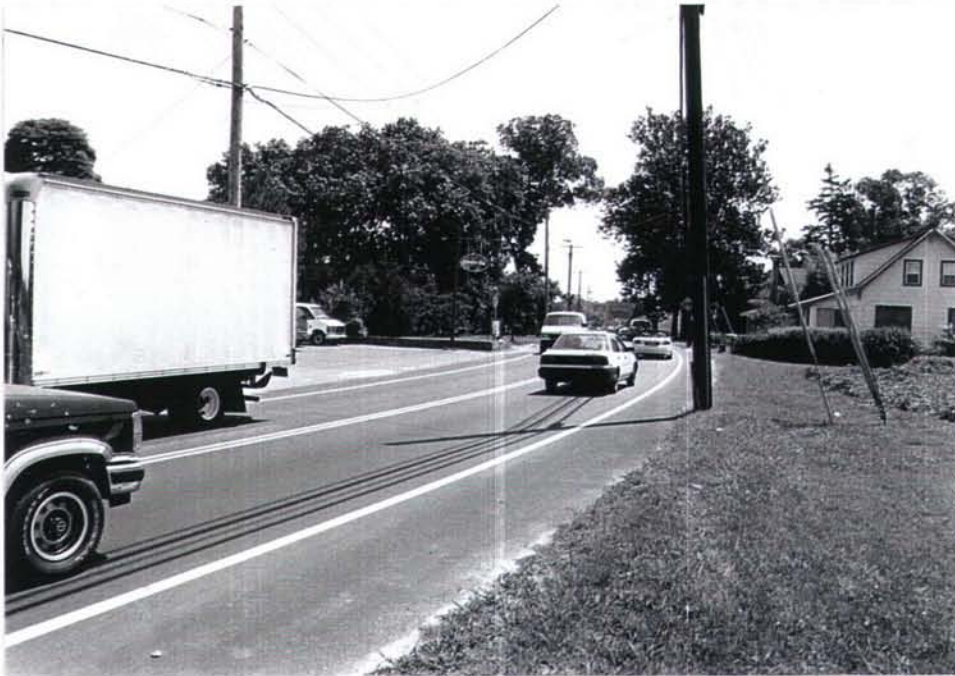
Photograph 1: Millville District, looking east down Route 26, west of the junction of Dukes Drive (July 2003). Many of the older residences and civic structures of Millville have been moved or demolished, destroying the feeling of Millville as a linear village.

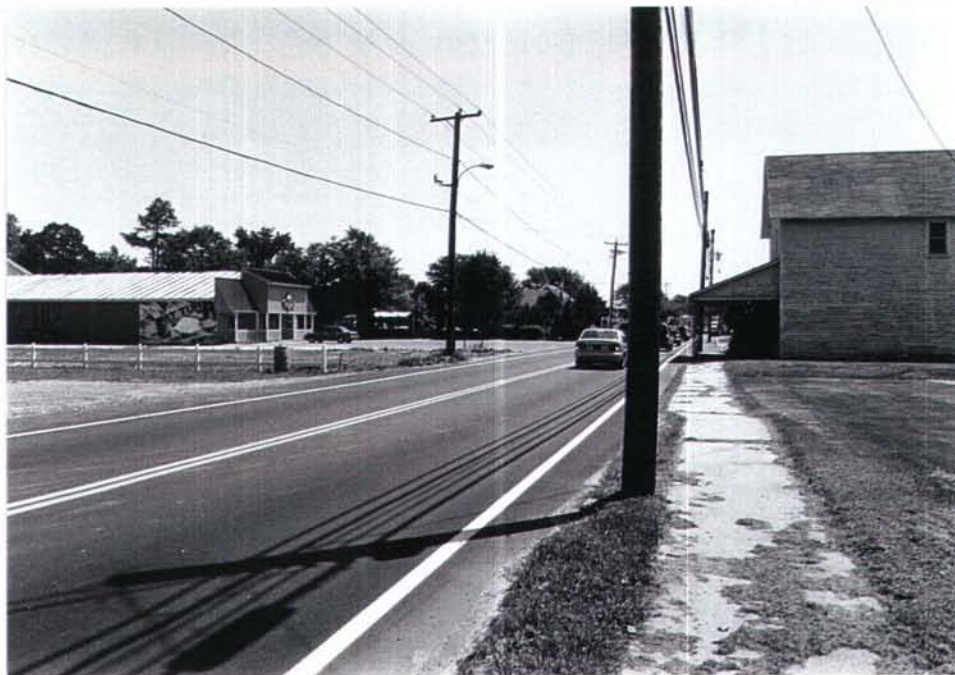
Photograph 2: Millville District, looking east down Route 26, east of Dukes Drive. S-2482 is seen on the right edge of the photo (July 2003). Modern infill, seen left, has diminished the feeling, and setting of the Millville District.

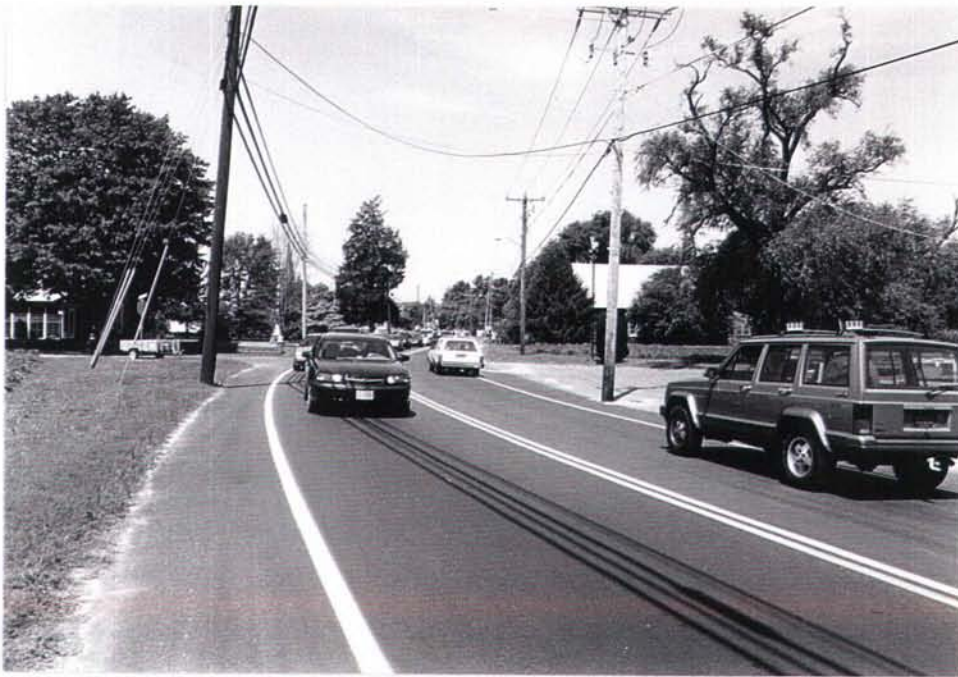
Photograph 3: Millville District, looking west down Route 26, east of Dukes Drive. S-9119 is seen in the extreme left side of the photo; S-9118 is seen right-center (July 2003). Little sense of the community feeling exists today in the Millville District along Route 26.
